## Update "With-Site-Visit" Reserve Study

### Richmond Manor COA Shoreline, WA

**Report #: 17195-2**  
**For Period Beginning: January 1, 2018**  
**Expires: December 31, 2018**

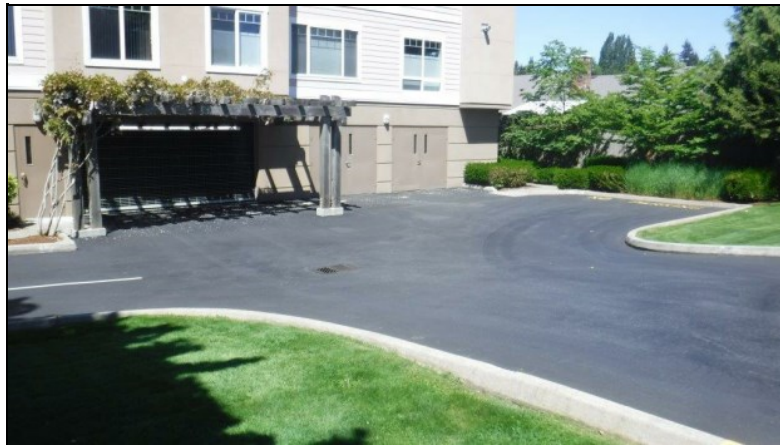
Useful Life:  
30 years

Remaining Life:  
15 years

Best Case: \$ 10,400

Worst Case: \$ 11,500

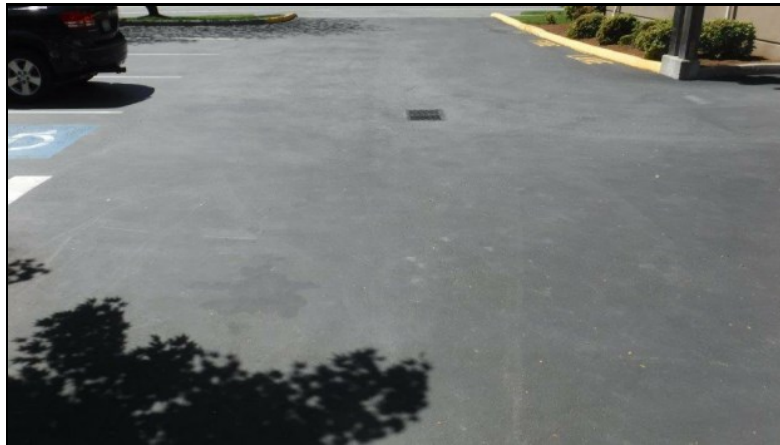
Useful Life:  
5 years

Remaining Life:  
1 years

Best Case: \$ 3,000

Worst Case: \$ 3,200

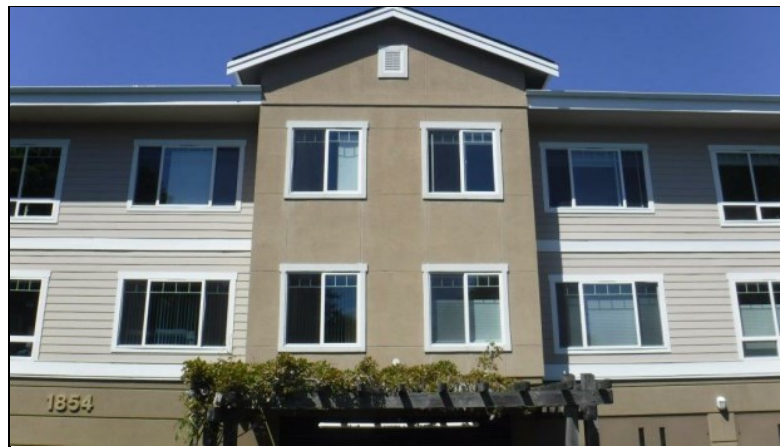
Useful Life:  
40 years

Remaining Life:  
25 years

Best Case: \$ 101,000

Worst Case: \$ 161,000

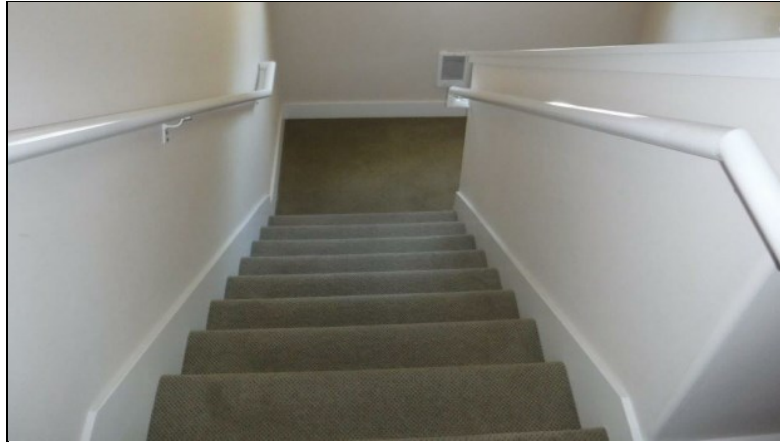
Evaluation: Stairwell surfaces appeared to be in fair condition.

Regular cycles of professional painting are recommended to maintain appearance.

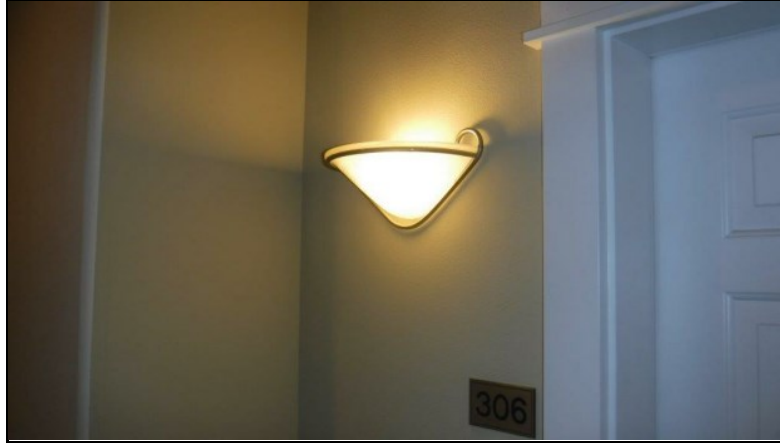
**Comp #: 720 Interior Lights - Replace**

Evaluation: Interior lights appear to be in good, functional condition.

With ordinary care and maintenance, there is no predictable expectation to replace all at once or in large scale at these protected interior locations. Evaluate needs each year and replace individual fixtures locally as needed using general maintenance and repair funds. If association desires aesthetic upgrade, funds can be included within reserve study updates.

As routine maintenance, inspect, repair/change bulbs as needed.

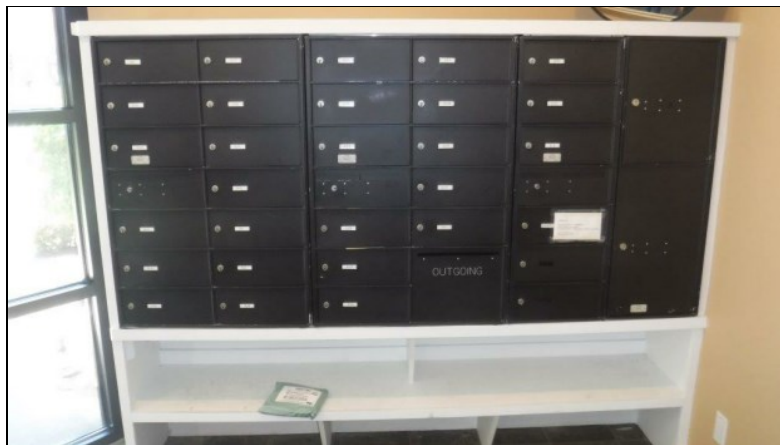
**Comp #: 730 Mailboxes - Replace**

As routine maintenance, inspect regularly, clean by wiping down for appearance, change lock cylinders, lubricate hinges and repair as needed from operating budget.

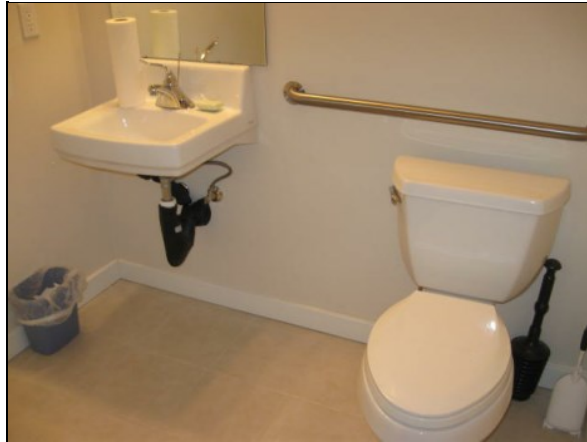
Evaluation: Functional, clean condition, no problems reported. We were informed that both bathrooms get very minor usage.

No expectation for large scale replacement within the scope of this report. We recommend that eventual refurbishment be factored into the general maintenance budget, not reserves.

As routine maintenance, inspect regularly, perform any necessary repairs promptly.

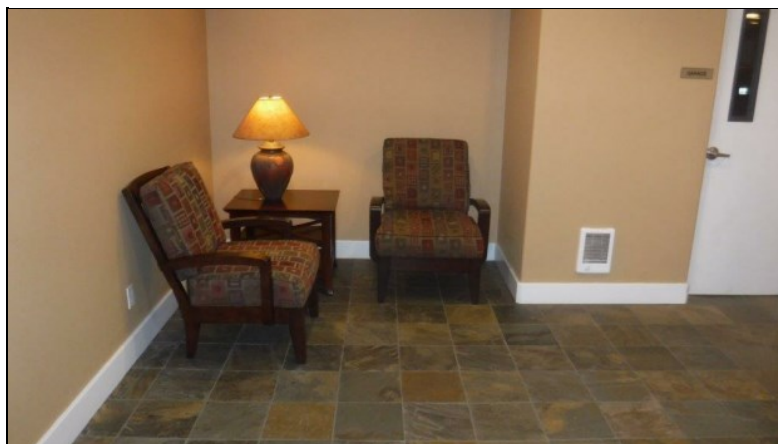
**Comp #: 760 Furniture - Replace**

Evaluation: Generally good condition and appearance noted.

This component suggests setting aside funding for periodic replacement / refurbishment of furnishings in order to maintain a quality aesthetic throughout. Typical replacements from similar communities include: sofas, chairs, wall décor, tables, etc... Follow roughly the time frame indicated below.

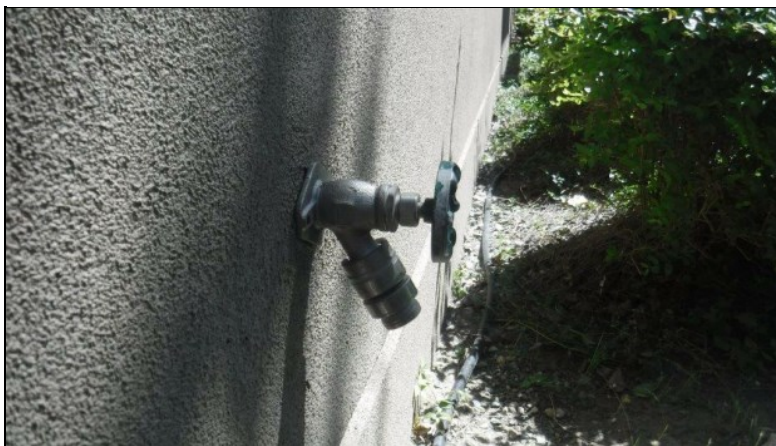
**Comp #: 900 Plumbing - Repair/Replace**

Treat minor local repairs as ongoing maintenance expense. If patterns of significant repair costs emerge, funding may be incorporated into reserve study updates to supplement the operating budget. No predictable basis for reserve funding at this time.

Some types of piping used historically are known to be life limited. Manufacturing defects also become apparent from time to time and certain site conditions can contribute to premature deterioration of system components. Regular professional inspections should be conducted.

Typically, if installed per architectural specifications and local building codes, there is no predictable time frame for large scale repair/replacement expenses within the scope of our report. If leaks, poor flow, sediments, defective material and/or installation become evident, have qualified plumber and / or engineer inspect closely and develop scope of any repair/replacement needed; funding for even one time projects can be incorporated within reserve study updates if basis exists.

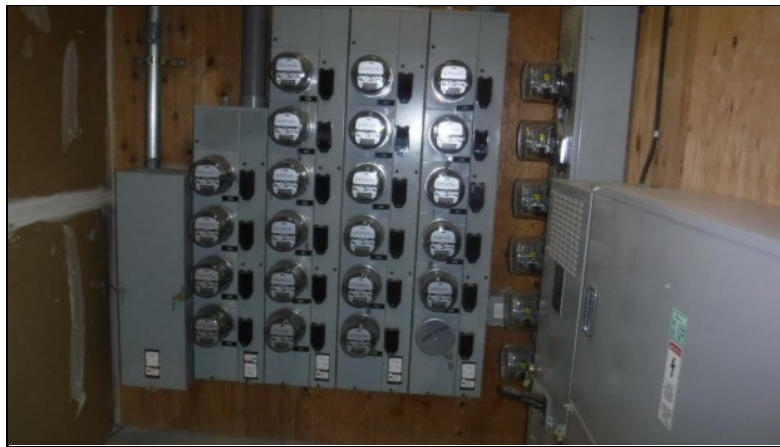
**Comp #: 905 Electrical System - Maintain/Repair**

Typically, if installed per architectural specifications and local building codes, there is no predictable time frame for large scale repair/replacement expenses within the scope of our report.

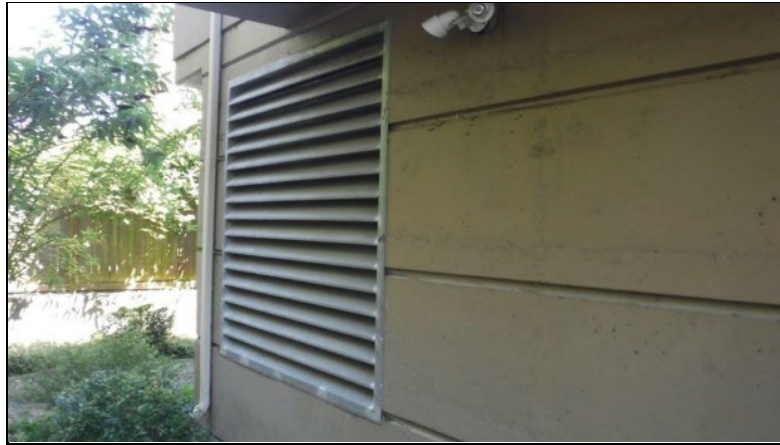
**Comp #: 915 Exhaust / Supply Fan - Replace**

Evaluation: Functional condition assumed, no problems reported.
