Update "No-Site-Visit" Reserve Study

Richmond Manor COA Shoreline, WA

Report #: 17195-3
For Period Beginning: January 1, 2021
Expires: December 31, 2021

Date Prepared: February 2, 2021

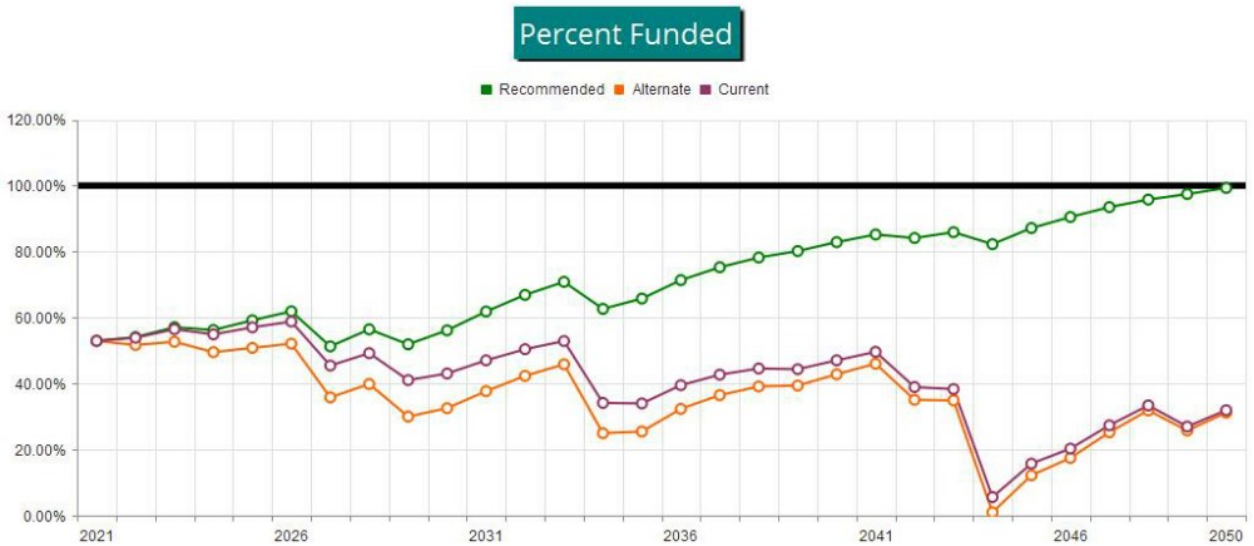
Figure 4

This figure shows the same information plotted on a Percent Funded scale. It is clear here to see how your Reserve Fund strength approaches the 100% Funded level under our recommended multi-yr Funding Plan.
